ALTICO SERVICE BULLETIN

#ASB 060700

SUBJECT: STIFFENER IN TOP FLAP OF DOLPHIN MAIN CONTAINER

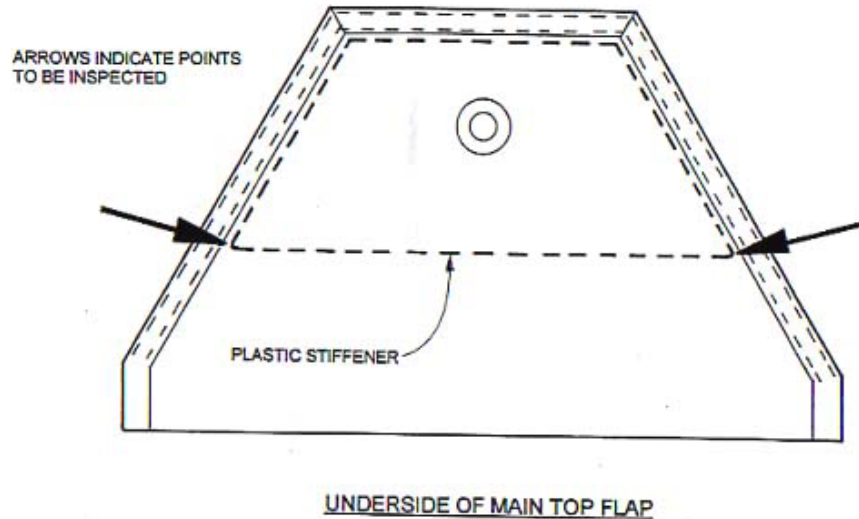
FIG. 1

- 1) Inspect underside of main top flap at points indicated in FIG. 1. If a corner of the plastic stiffener is exposed by wear, proceed to step 2.
