DATE: May 23, 2011

SERVICE BULLETIN #20110523

SUBJECT: Inspection of the top diagonal attachment point on all Vector 3 Sport and SE Student Harness/Container Systems.

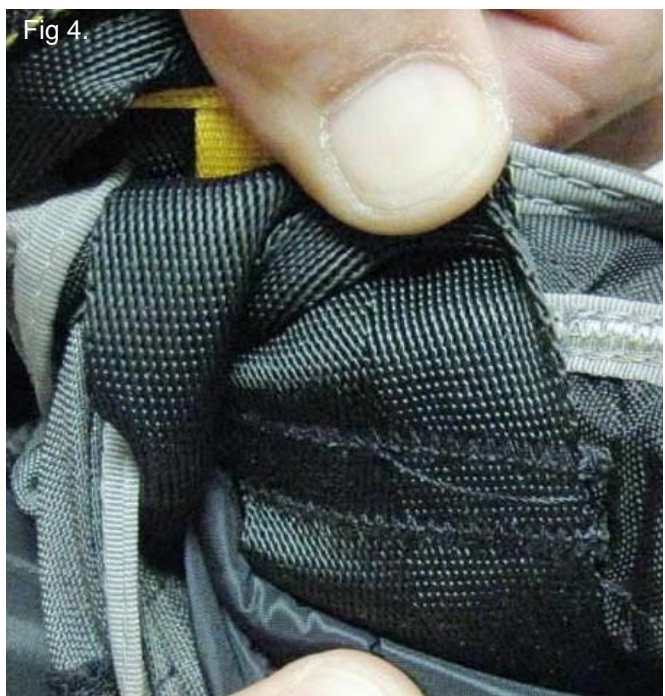
Figures 3 and 4 show examples of undamaged stitch patterns. Undamaged stitch patterns such as these do not require repair.

SERVICE BULLETIN: Before the next jump it is strongly recommended that all jumpers inspect this area for broken stitching. This can easily be done on packed rigs by simply opening the reserve pin cover and riser cover, then work your thumb up under the diagonal to expose the zigzag stitching. Only the top inside section of stitching needs to be inspected (Figure 3). Consult your local rigger if you are unsure or have any questions.

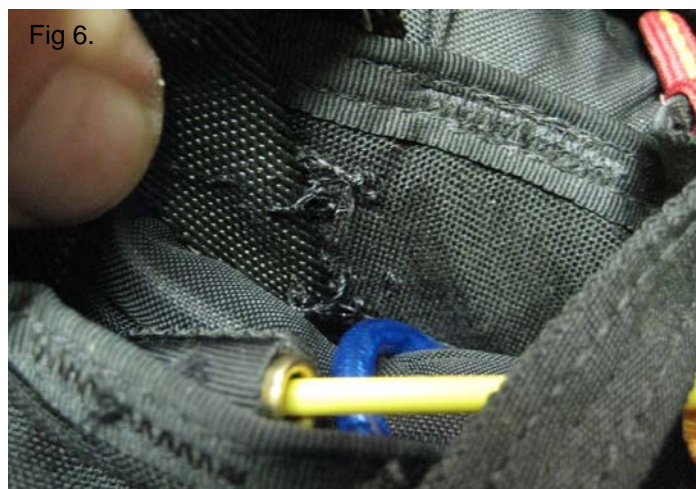
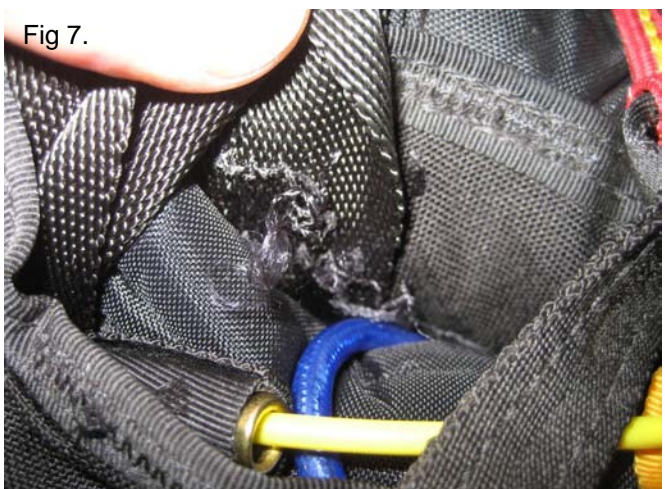
Figures 5, 6 and 7 show example of failing stitch patterns in need of repair.

If the diagonals are in need of repair, riggers in the field are now authorized and requested to make this zigzag repair using “E” shape stitch pattern. This “E” shape zigzag stitch pattern is the same pattern that has been in use on the Sigma Tandem system for some time.
