## SERVICE BULLETIN no. 01/01/2014

### Inspection of the sporting parachute containers

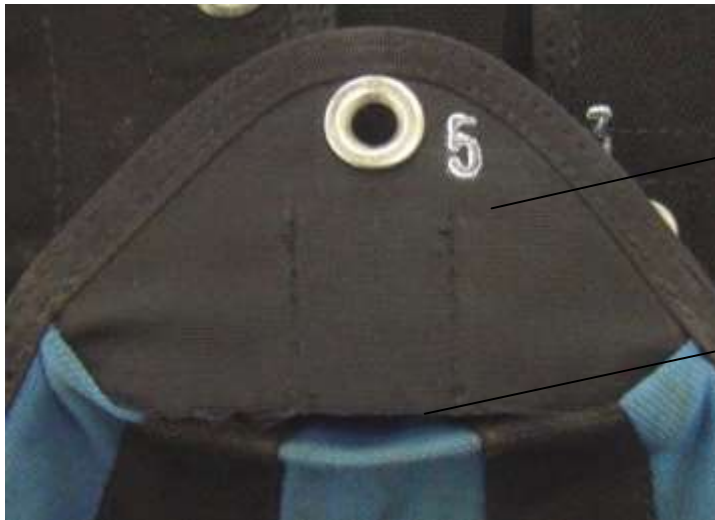
Fig. no. 1 - detail of the lower (central) reserve parachute container flap

1. **SUBJECT MATTER:** Parachute container  
OP – 093/ 01, sizes 1 and 2  
OP – 087 of all produced sizes,  
with completed lower (central) flap of the reserve parachute container in such way the external fabric covering the reinforcement has the same length as the reinforcement – see annex no. 1, fig. no. 1 or the fabric exceeds the reinforcement edge by less than 15 mm (measured in the flap centre).

2. **REASON:** The reserve parachute container flaps failed to open completely during the exercise land opening of the reserve parachute container in the above design, after releasing the ripcord handle reserve. The upper covering flap of the reserve parachute container remained trapped behind the reinforcement edge of the lower (central) flap of the reserve parachute container.

the fabric exceeds the  
reinforcement

the reinforcement edge

**Manufacturer:** Performs the repair work of the lower (central) reserve parachute container flap.  
**Warning:**  
In case the parachute does not comply with the design specification as per point 1 and the fabric length will exceed the reinforcement edge by more than 15 mm (measured in the flap centre), **its further use is possible in operation.**  
The person performing the inspection confirms the state by recording „complies with SB no. 01/01/2014“ in the Technical certificate of the parachute container with the harness in the table of repair works and inspections.
