## PRODUCT SERVICE BULLETIN

Bulletin Number: FB 2021-01

SUBJECT: Firebird V1R1 EVO Harness container systems with adjustable Main Lift Web

STATUS: MANDATORY INSPECTION BEFORE NEXT JUMP

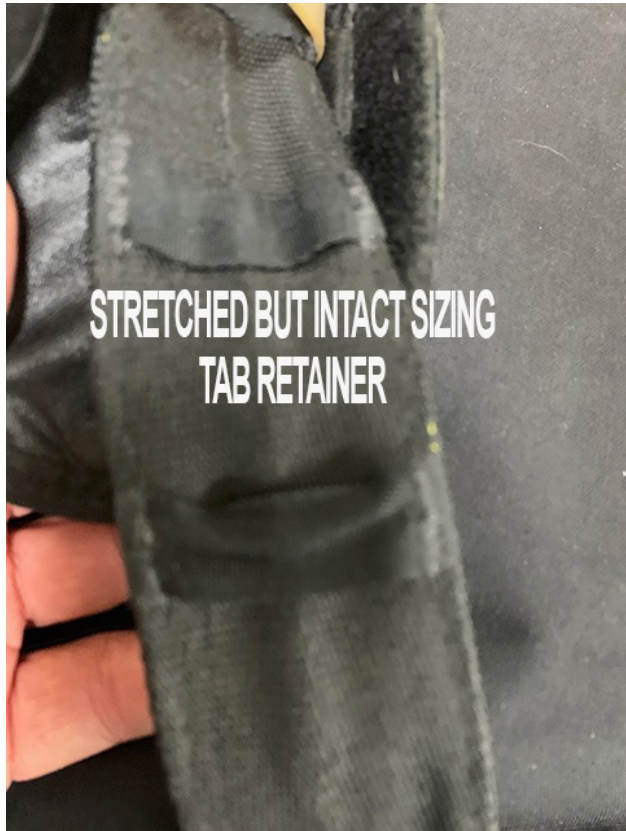
**Right** Main lift web undone, sizing safety tab ripped off and stuck under a stretched but intact sizing tab retainer (1/2" type 1), 555-2 ring installed **correctly**, **missing** spring, **NO** damage to type 4 stopper.

From the stretch marks of the sizing tab retainer, we think that the misrouting happened not too long ago by a third party during the rental process and that it went unnoticed for an unknown period by anyone involved in the rental process and handling of the container.

#### Stretched tab retainer

To make sure that in the future only qualified Riggers can disassemble the main lift web, we strongly recommend replacing the type 4 stopper with four layers of type 17 webbing and sew a BOX X pattern with at least 5-cord. Firebird USA LLC uses exclusively 6-cord.

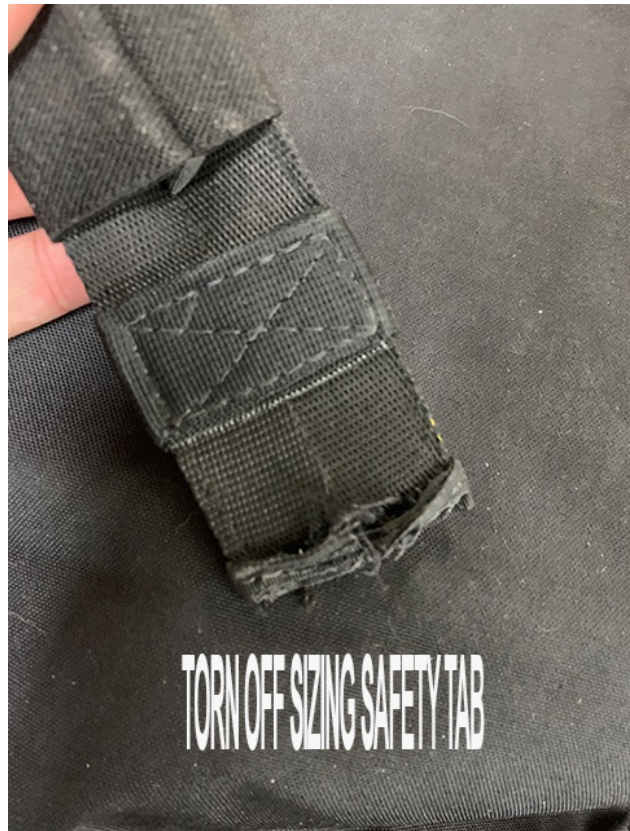
In this incident, it appears that, the only thing that kept the webbing from coming undone, was the engaged sizing safety tab in the type 1 sizing tab retainer and that it subsequently broke under the load of the opening as **zero** damage to any other component occurred.

The right main lift web of the affected container that came undone does **not** show any damage on the type 4 stopper with only the sizing safety tab torn off and matches only the findings of at least one configuration of those simulations carried out by Firebird.

#### Torn off tab, damage free type 4

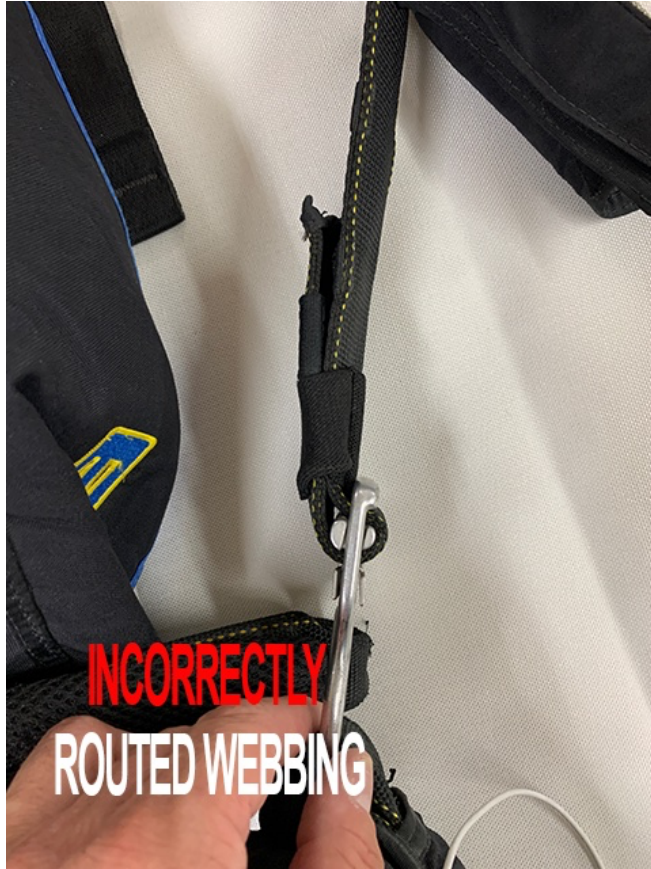
**Side view**

**Left** Main lift web threaded **incorrectly** (double routing, wrong direction, see pics), sizing safety tab attached with only a few stitches (69tex/E thread) ripped, sizing tab retainer stretched but intact, 552-2 ring installed **correctly**, spring present, **NO** damage to type 4 stopper.

The incorrectly routed webbing on the **left** side strongly indicates that, the **right** side that came undone, most likely also had been routed incorrectly.

*Incorrectly routed webbing will result in a slippage towards the open end and in opposite direction of the engineered purpose as the friction lock will not properly engage and not properly block the webbing from slipping.*

## **INCORRECT** ROUTING PRESENT ON EVO 8611-172

Therefore, we mandate a visually inspection before the next jump, to confirm the correct routing of the adjustable main lift web through a type 555-2 ring (DJA/CWH) especially if the container has been disassembled for repairs, maintenance, cleaning, or any other reason. All direct customers have been contacted by Firebird USA LLC.

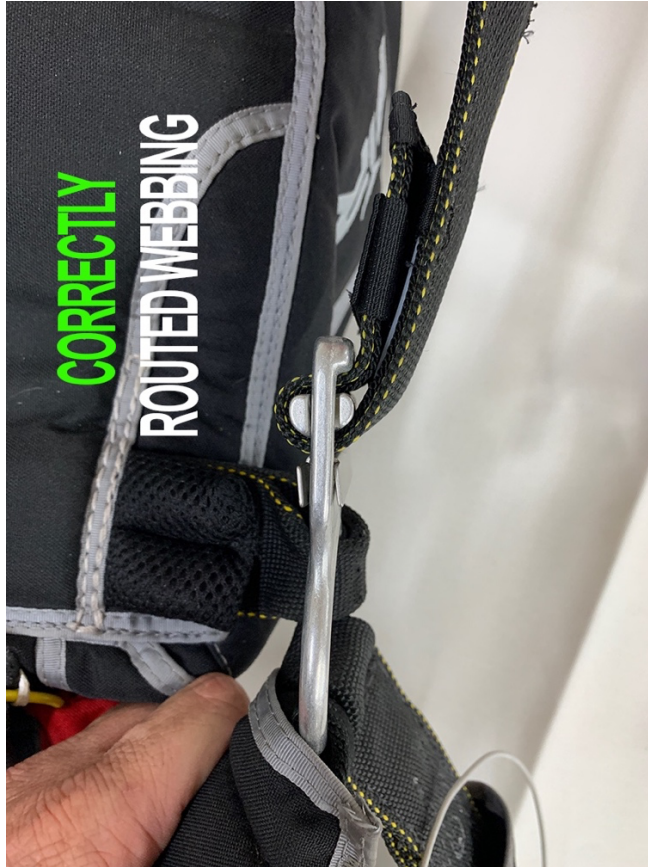
**Side view**

**!!!! CORRECT ROUTING !!!!**

Always inspect the correct routing of the main lift web before use, especially if the harness-container is in a rental, demo or student setting or was recently in maintenance.
