Objet : Sacs OMEGA de la Société PERFORMANCE VARIABLE

## DIRECTIVE TECHNIQUE N° 15

Sac-harnais OMEGA de la société PERFORMANCE VARIABLE,  
modèles XXS, XS, M, L, XL et TANDEM

Personnel Parachute OMEGA ( ) / QUICK ( ) - OMEGA Container-System - Modification of Flap-No. 3, Visual Inspection of Bartecs, and Equipment Handbook Change

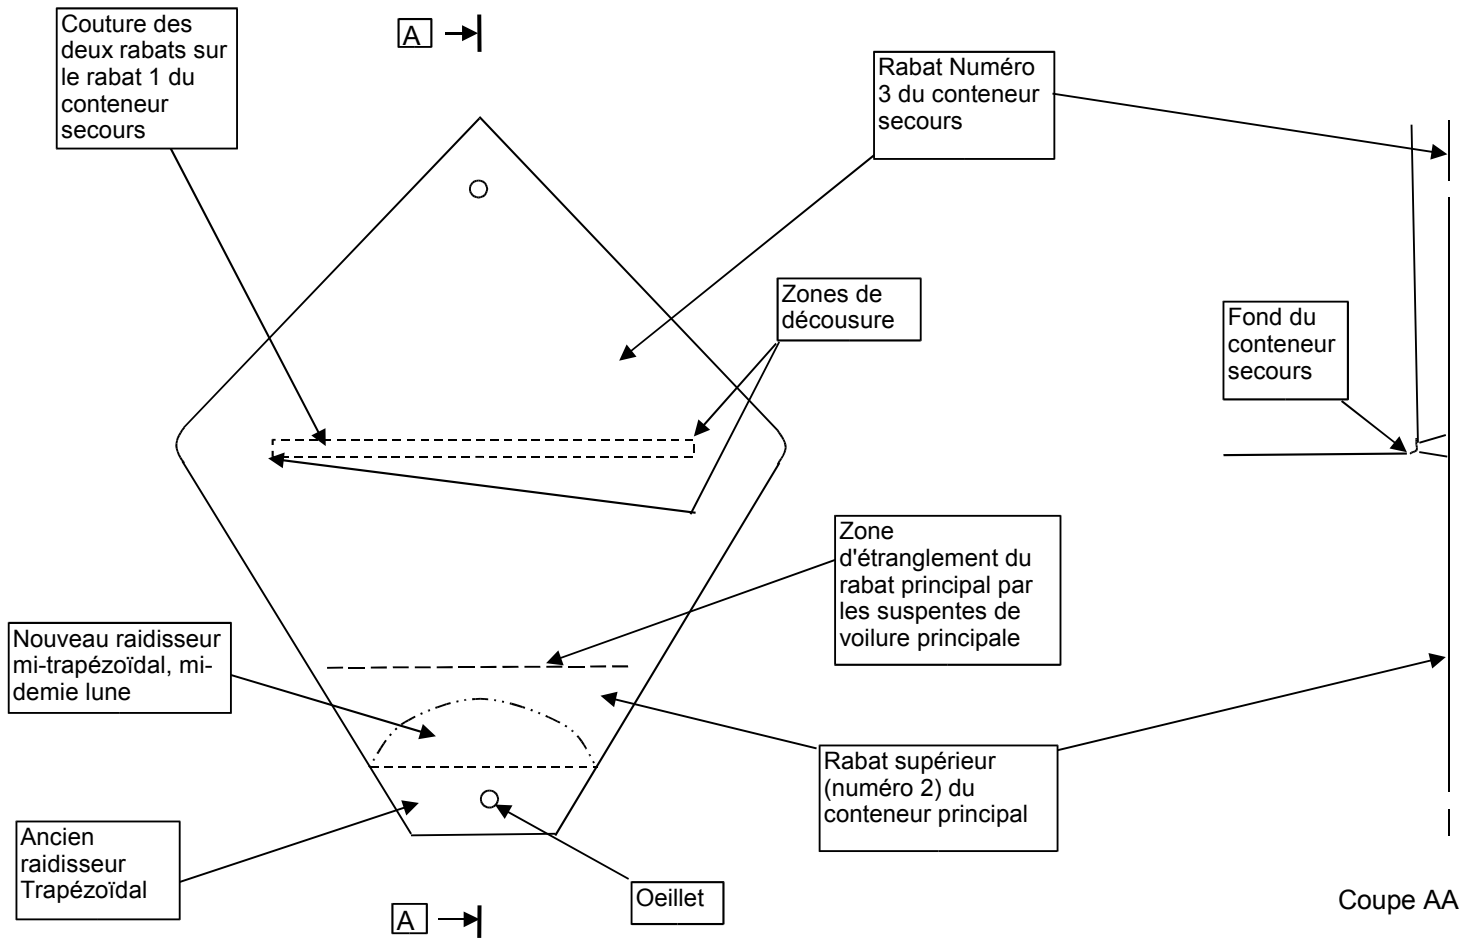
**Schéma de l'ensemble des rabats supérieurs**

- ✓ L'analyse des matériels :
  - Montre que le rabat en cause dans les incidents et accident fait partie d'un ensemble rabat inférieur du conteneur secours (rabat numéro 3) et supérieur du conteneur principal (rabat numéro 2). Formé d'une seule pièce, il est relié au rabat numéro 1 du conteneur secours par une couture de 160 mm environ (modèle XS). Dans le rabat supérieur du conteneur principal est inséré un raidisseur trapézoïdal supportant l'œillet (voir schéma)

- Montre la possibilité d'interférence entre la base du rabat du conteneur principal au niveau de son agrafage sur la base du conteneur secours. Cette couture laisse une partie libre entre le rabat et le conteneur secours (voir schéma)

- Montre la possibilité d'étranglement, par une ou des suspentes, du rabat supérieur du conteneur principal entre son agrafage et le raidisseur trapézoïdal, support de l'œillet (voir schéma : Annexe 4)

- Montre une évolution du raidisseur sur les derniers sacs-harnais produits vers un modèle dont le grand coté du trapèze est en demie lune (voir schéma)

- **l'application du Bulletin service** : SB-0-200501 en date du 18 juillet 2005 émis par la société PERFORMANCE VARIABLE.
- **La mise au dernier standard** du rabat supérieur du conteneur principal par changement du raidisseur trapézoïdal pour celui mi-trapézoïdal, mi-demi-lune du dernier standard 2005.
- Les travaux devront être obligatoirement être effectués par le constructeur ou par un organisme habilité par écrit par lui.
- Les travaux seront consignés dans le livret parachute.
