PRODUCT INFORMATION BULLETIN

Bulletin Number : PIB-01-2017

Subject : VIGIL CUTTER DEFORMATION

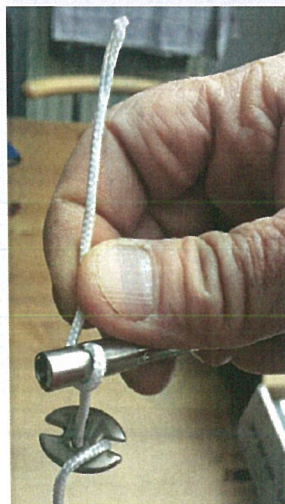
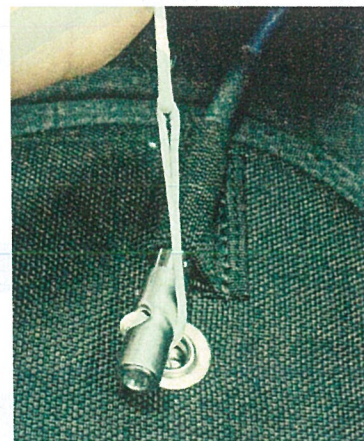
We recently have found a few cutters in the field that showed clear indentation marks around or near the reserve-loop hole on the cutter sleeve.

Upon further investigation and after conducting numerous tests during reserve container closures, we have discovered that these indentations are caused when the reserve loop has been routed incorrectly when using a skydiving harness/container where the AAD cutter is placed on top of the floor plate at the bottom of the container.

By doing so, the useable length of the reserve closing loop will obviously be much shorter than the manufacturer's recommendation and in most cases this misrouting won't be visible once the reserve freebag has been placed on top.

It is strongly advised that ALL VIGIL CUTTER UNITS that are or were previously installed in a harness container system where the cutter is placed at the bottom of the reserve tray against the floor plate and that clearly show these type of indentations, should be sent back to AAD or Vigil America for inspection and consequently a possible replacement.

Advise: inspection recommended during the next reserve repack.

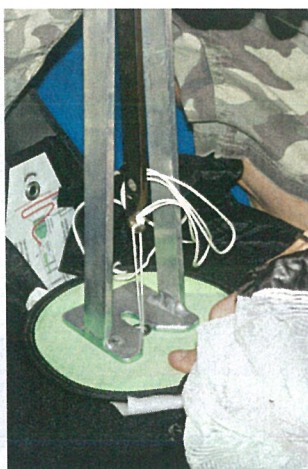
The damage to the cutter sleeve therefore also occurs when using a packing/closing tool that provides extra noticeable leverage and ease of closing. The use of these tools are pretty popular amongst parachute riggers and demand less physical strength and effort to close but do not provide any feedback of actual pull force being used or need in order to close the container.

When the reserve container is being closed without the use of any leverage tools, it becomes pretty obvious that the required loop length is insufficient and therefore probably misrouted.

We, AAD, nv / Vigil America, Inc, do not advice against the use of these tools but strongly recommend to verify the correct routing of the reserve loop before closing the reserve container.
