SERVICE BULLETIN No. 11/09/2010

Check of Ripcord Handle Pins

5. ATTACHMENTS: Attachment no. 1 – Photos of ripcord handle and ripcord pins

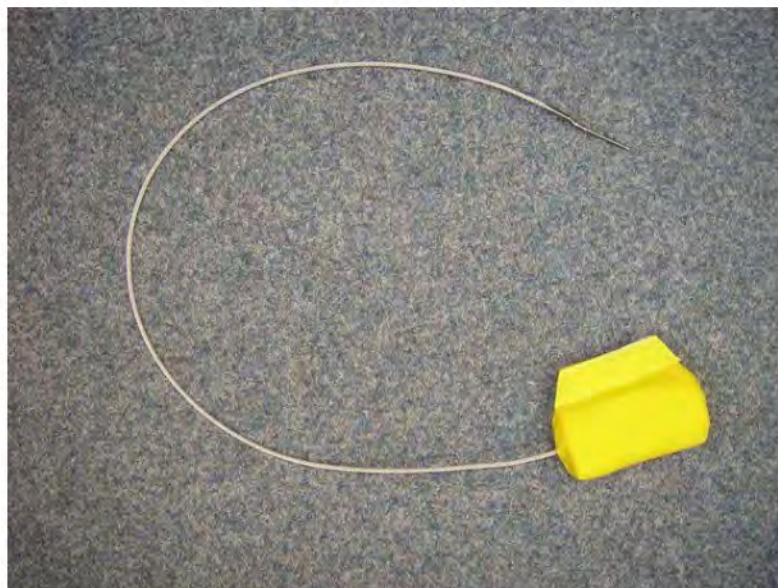
Pic. 1
Ripcord Handle U-064

- 1. APPLIESTO:** the pins of ripcord handle reserve parachutes U – 064 (pic.1), U – 051 (pic.2) and U – 069 (pic.3), produced by Synek company (pressed pins – hexagonal press, see pic. 4 A - straight and pic. 4 B - bent), which are parts of:

- 3. MEASURES:**
- A user or a packer licensed to pack the reserve parachutes (authorized person) proceeds a check of the ripcord handle pin at the products mentioned in part 1 and in case the pin body is found damaged, he/she puts the parachute set out of service.

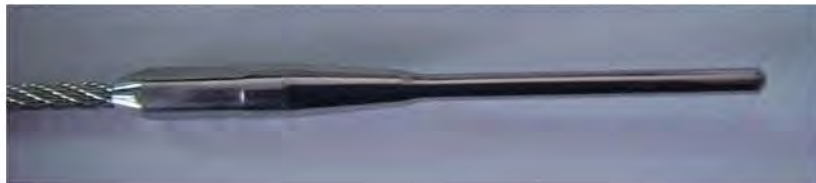
- 2. REASON:** During multiple tests for attestation of power for tearing off the ripcord handle it was found out gradual increase of the power beyond the permissible range that is defined by the regulation (22,2 to 97,9 N). During analysis of this situation it was found out that during the multiple tearing-off the ripcord handle the surface of the ripcord pin body can be damaged. This state can further cause an increase of power needed for tearing off the ripcord handle.

Service bulletin **refers to** these pins:

Pic. 4 A
Pressed pin – straight, hexagonal press (e.g. the press at the line has the hexagonal shape)

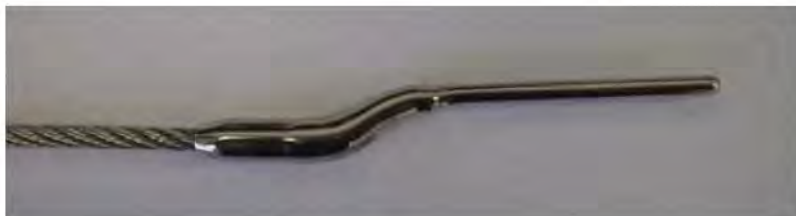
Pic. 4 B
Pressed pin – bent, hexagonal press
