Objet : Sacs OMEGA de la Société PERFORMANCE VARIABLE

## DIRECTIVE TECHNIQUE N° 15

Sac-harnais OMEGA de la société PERFORMANCE VARIABLE,  
modèles XXS, XS, M, L, XL et TANDEM

Personnel Parachute OMEGA ( ) / QUICK ( ) - OMEGA Container-System - Modification of Flap-No. 3, Visual Inspection of Bartecs, and Equipment Handbook Change

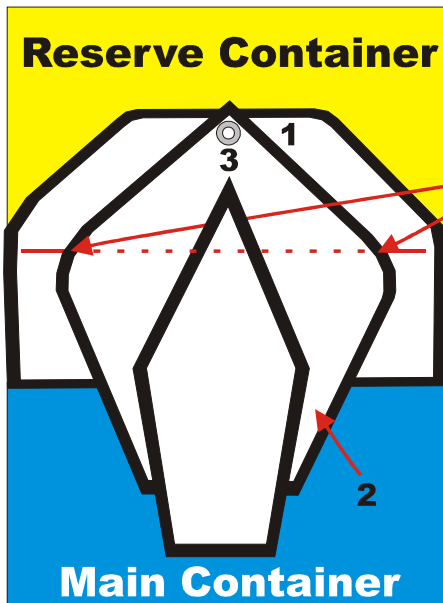
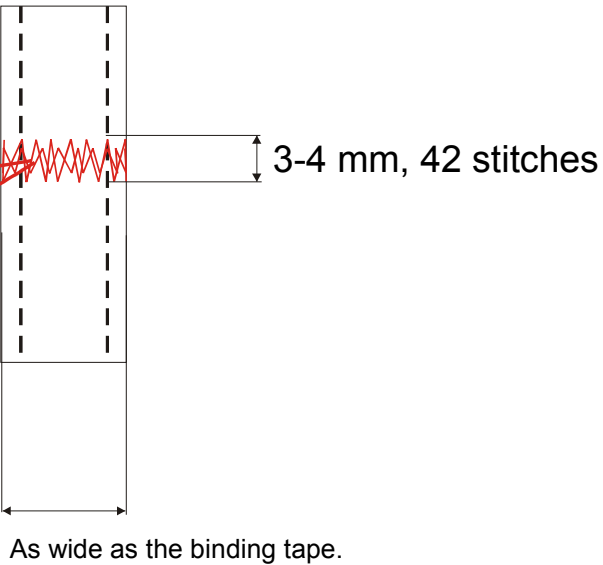
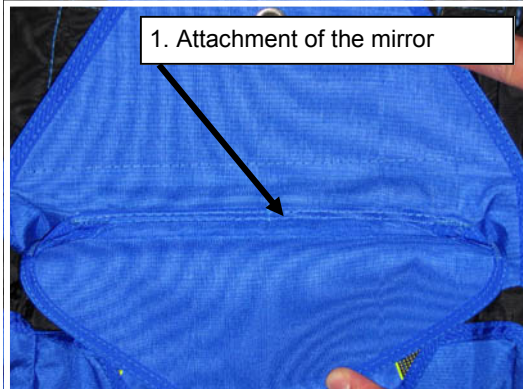
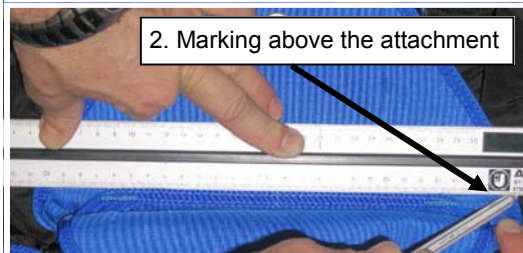
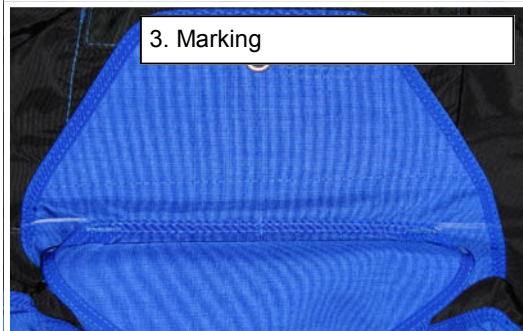
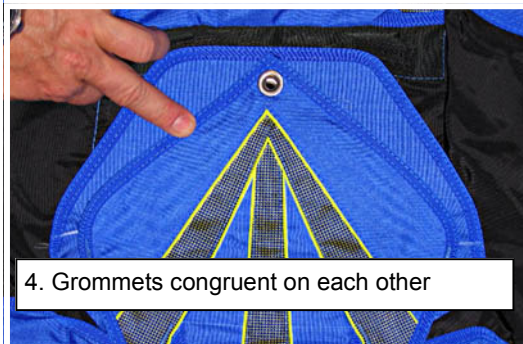
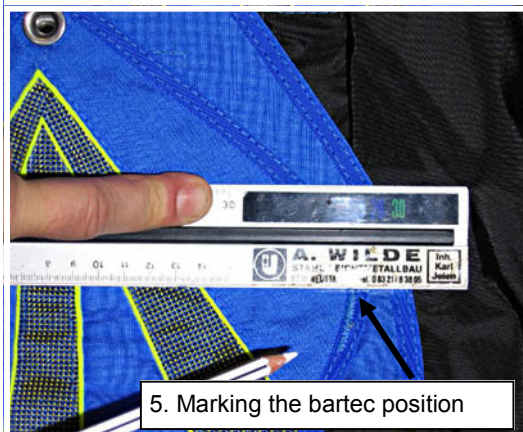
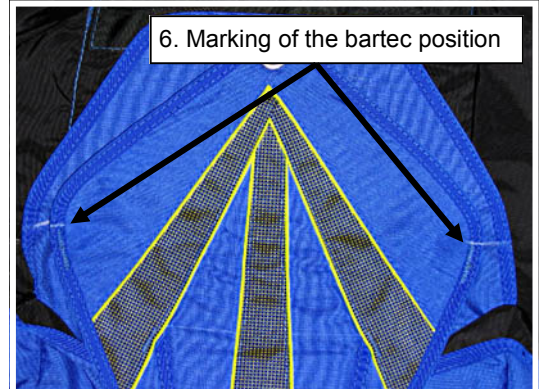
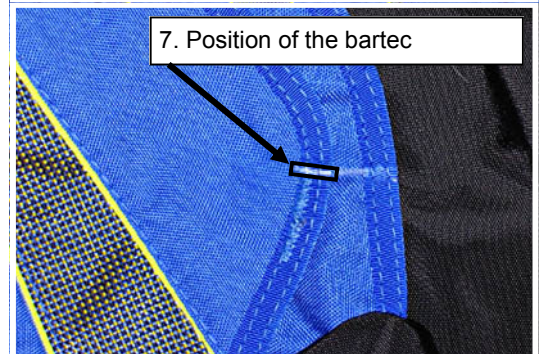
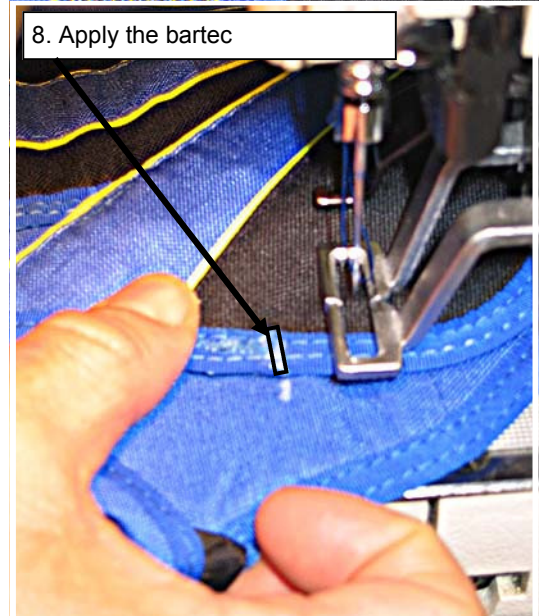
Analysis: A combination of a couple of facts can cause line entanglement with flap No. 2 of the main container.

Bartec specification see drawing below!

To avoid failure like written above and during improper use of the equipment in the future, the mirror (Flap No. 3 of the reserve container) must be sewed at the round corners with two short bartec to the flap No. 1 of the reserve container. This avoid contraction of the flap under tension while a line is tucked under. And it is easier to turn up the flap to release a line.

Use only Typ E / 40, Nylon Bonded thread!
