Advisory Service Bulletin (PSB #2016-02)

Bulletin number: PSB-2016-02

Subject: Reserve Pin Protector Flap Snag Possibility On UPT Style RSL/SkyHook Pin

Sport Vortex Containers manufactured with RSL/Skyhook UNIVERSAL LANYARD P/N: 025-009-001

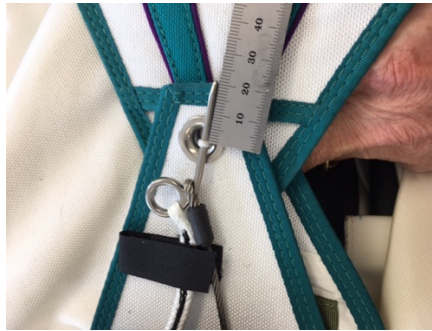
1. If you find that your flap is snagged/caught and hard to open, please stop pulling immediately, push the pin protector flap back into place, then push a finger in between the flaps near the pin and then carefully pull back on the flap and open it.
2. You can inspect the pin from the side by turning the rig on its edge and lifting up the one edge of the pin protector flap. Look at the pin to see how far it is inserted into the closure loop. If it looks like it isn't in deep enough, carefully open the flap and ease it further in. (DO NOT PUSH THE PIN IN TOO DEEP)
3. The suggested length the pin should be inserted is approx. 21 mm from the edge of the Cypress type closure loop to the tip of the pin, no more!! There must be a slight slackness in the white spectra RSL line.

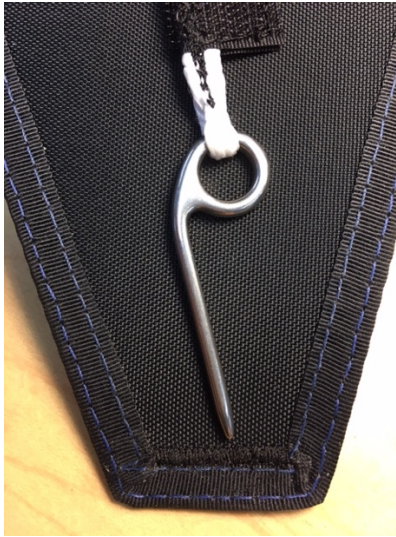
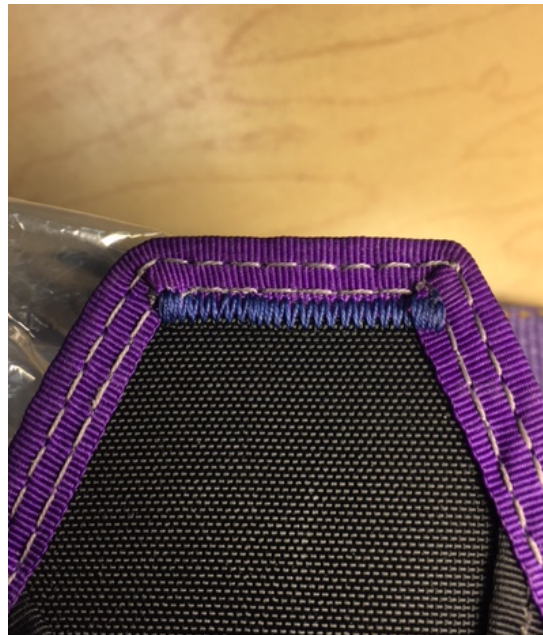
The pin being used with the Skyhook/RSL installation is longer than a normal ripcord pin and extends beyond the lower closure flap (last flap to close) edge. This can occasion the 'catching' (snagging) of Rsl/Skyhook pin on the binding tape edge, between the edge of the tape and the double needle stitch line (plus minus 2 to 3 mm in width). If a jumper continues to pull back and up (which is normal for opening the flap) this can move the pin backwards and activate the reserve.

Method of repair: Set tension and stitch length of the zig-zag (use a tight throw stitch pattern / see picture)

Open up the pin protector flap and place the tip under the foot of the sewing machine (para - pack side up). Run a zig zag stitch across the end portion (approx. 4mm wide) with a throw being each side of the edge of the binding tape, (i.e. binding tape edge runs in center of the stitch). Put a small back tack at the beginning and end of the line of zigzag stitching. Trim thread and inspect. The end result should resemble above picture.
